[Docket No. FAA-2006-25760; Directorate Identifier 2006-CE-48-AD; Amendment 39-14757; AD 2006-18-51]

Airworthiness Directives; Raytheon Aircraft Company Models 1900, 1900C, and 1900D Airplanes

2006-18-51 Raytheon Aircraft Company (RAC): Amendment 39-14757; Docket No. FAA-2005-25760; Directorate Identifier 2006-CE-48-AD.

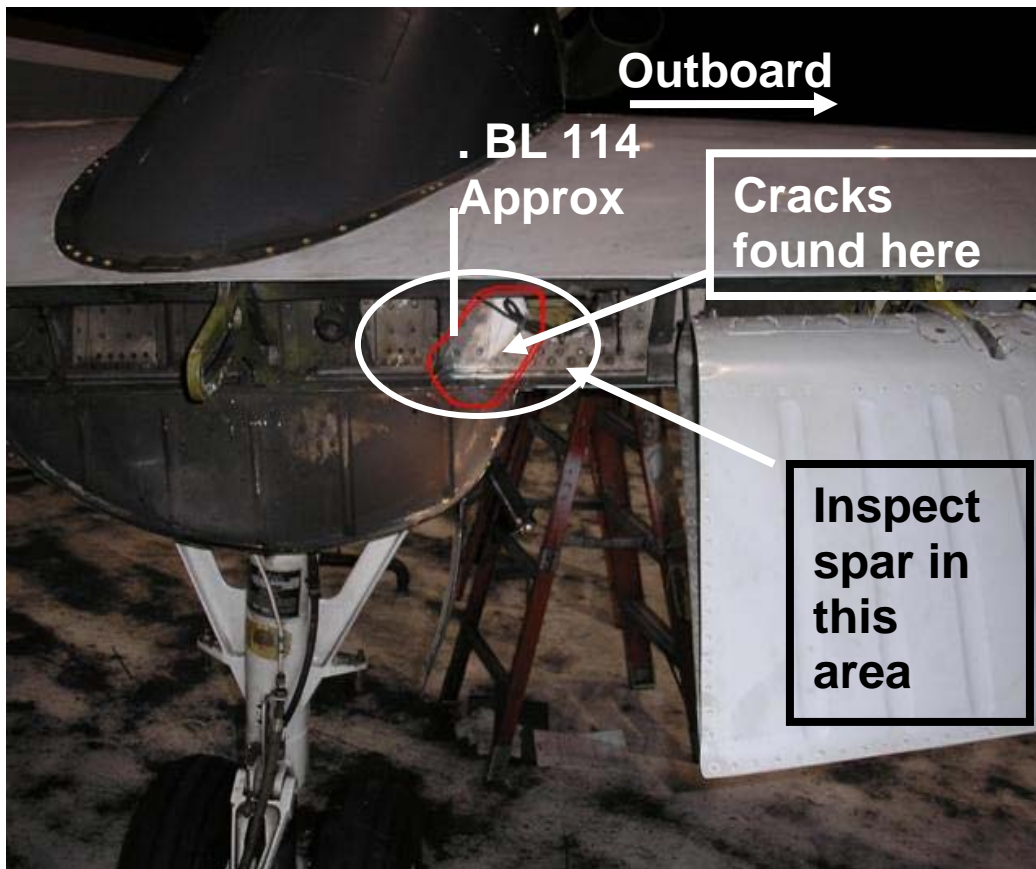
Step 2. Using a strong, high-intensity light visually inspect the area of the wing rear spar identified in Figure 1. There is ample visually visual access from above the upper surface of the flap. Look for cracks (like those shown in Figures 2 and 3) and loose or missing fasteners.

Figure 1: View of R/H wing rear spar at BL 114 area looking forward (The inboard flap is removed in this figure, but removal of the flap is not required to do the inspection).

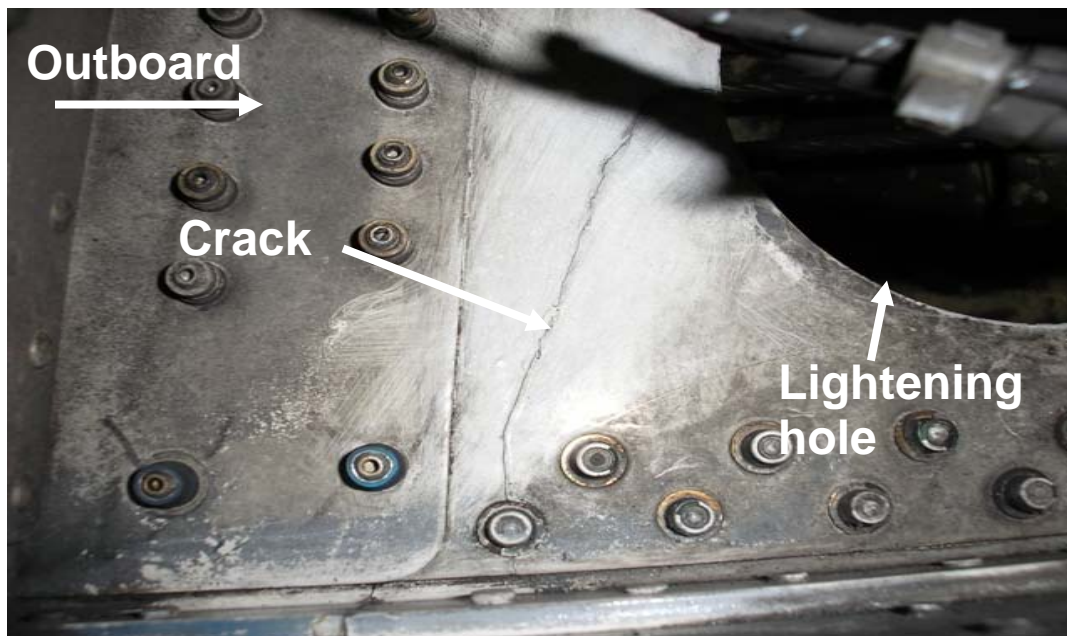
One airplane had 19,126 hours TIS when cracks were found. The cracks were in the lower aft spar cap flange, but the cracks extended upward into the web and terminated at the lightening hole in the spar web. Fasteners were also found missing in the spar cap and wing cove splice plate. There were no discrepancies recorded from the initial inspection at 17,500 hours TIS on this airplane.

Figure 2: Closeup view of R/H wing rear spar web crack at BL 114 area looking forward (The inboard flap is removed in this figure, but removal of the flap is not required to do the inspection).

(3) Repair any cracks or other damage such as loose or missing fasteners found during the inspection required in paragraph (e)(1) of this AD. Do this by obtaining and incorporating an FAA-approved repair scheme from RAC.	Before further flight after the inspection required by paragraph (e)(1) of this AD.	Contact RAC at Post Office Box 85, Wichita, Kansas 67201-0085; phone: 316-676-8366; fax: (316) 676-8745; email: tom_peay@rac.ray.com .

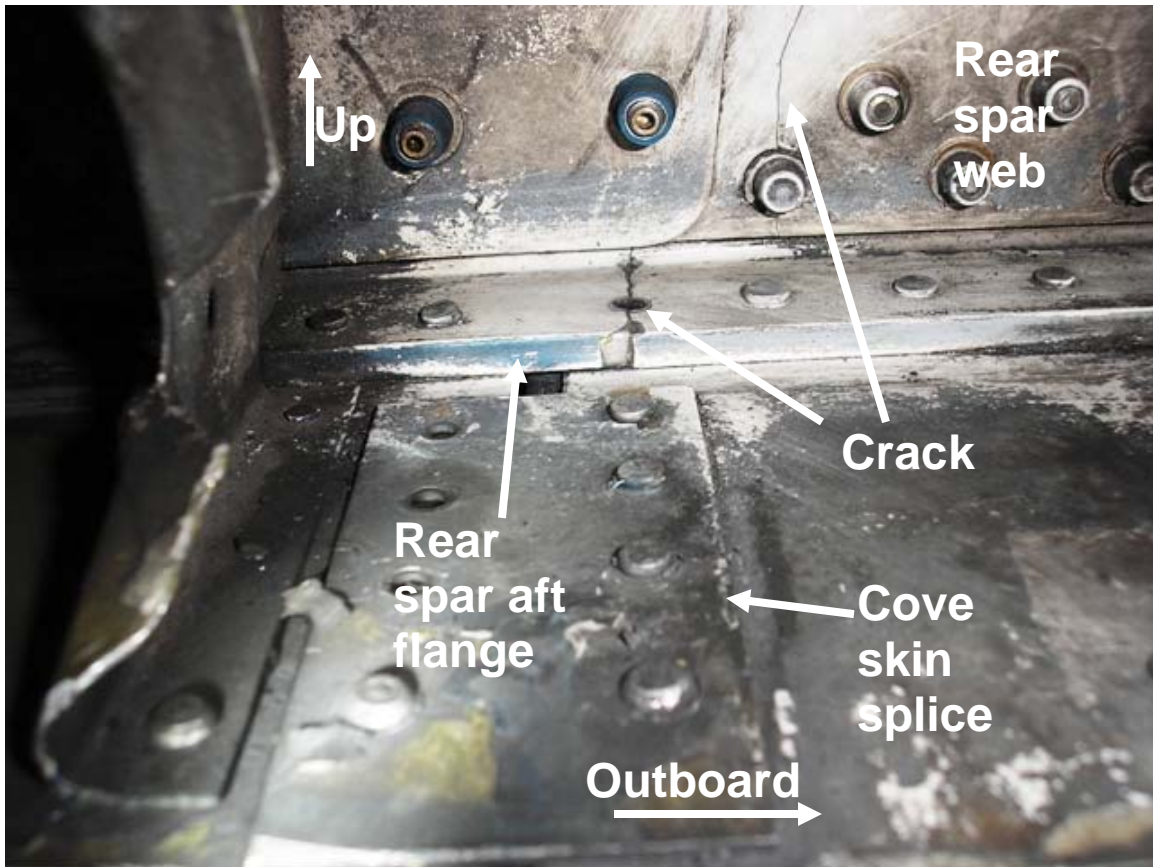
Figure 3: Closeup view of R/H wing rear spar cracks at BL 114 area looking forward (The inboard flap is removed in this figure, but removal of the flap is not required to do the inspection).
